## LIFE Peat Restore

**LIFE project «Reduction of CO<sub>2</sub> emissions by restoring degraded peatlands in Northern European Lowland»**

# **State of the project site and consequences for project implementation**

# **ESTONIA**

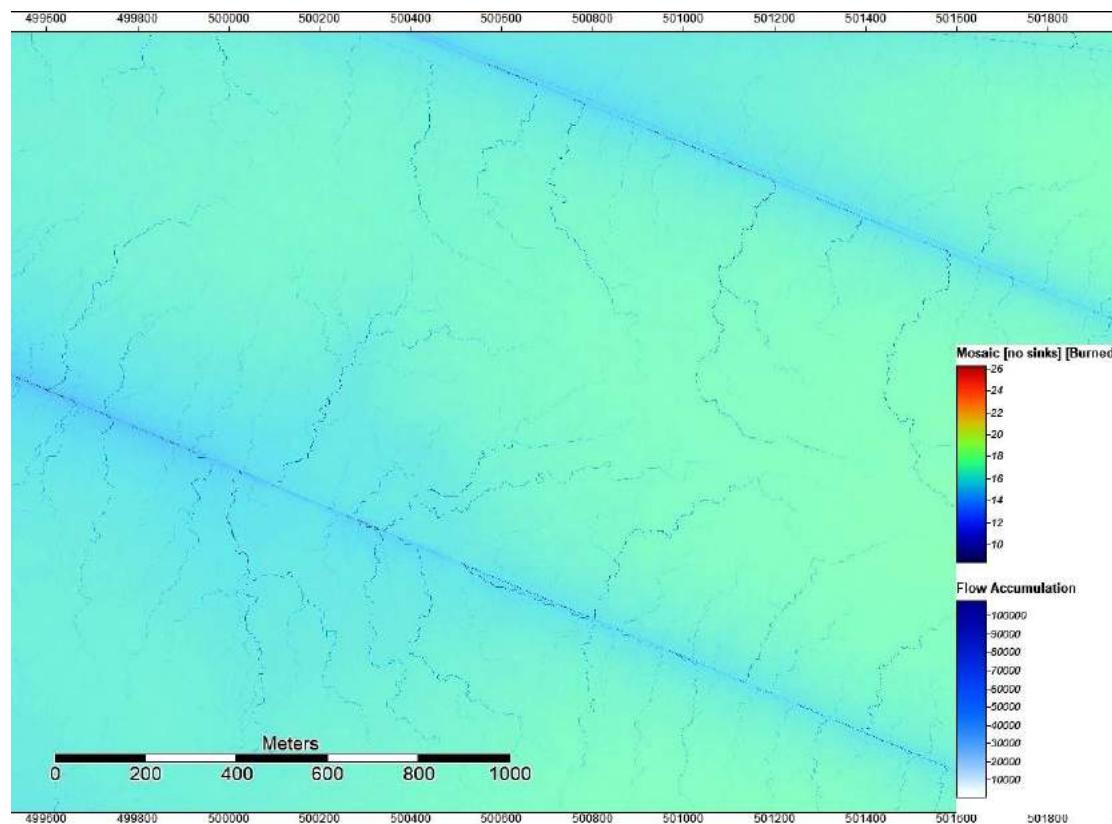
*Fig. 2. Example of the surface elevation and flow accumulation map (middle part of the restoration area). Surface slope and flow lines are aligned towards the large ditches.*

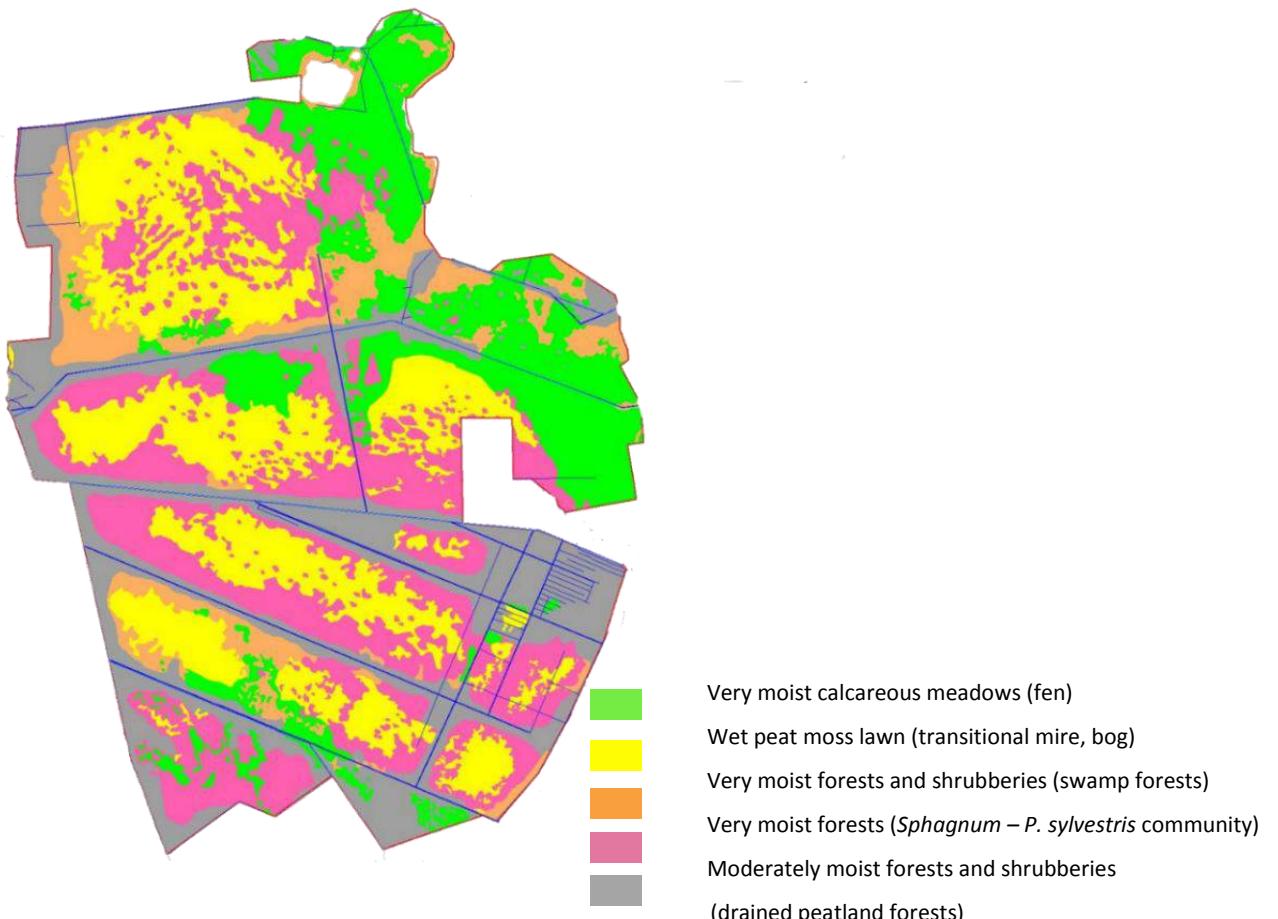
*Fig 3. Distribution of the GEST types on the Suursoo-Leidissoo project site. Blue lines are ditches.*

Distribution map of the GEST types indicate that more drained types located close to the ditches and more natural types located on the larger distance (at least 100-200 m) form ditches. Exception is Very moist calcareous meadows (fen) that is crossed by the larger ditches, which have not very strong impact. This is caused by small surface gradient and activity of beavers on these areas. Water level monitoring data indicated that character of vegetation and natural state of the GEST types is related strongly the strength of the drainage impact. Drained types have much deeper water levels and larger water levels amplitudes compared with more natural types (Table 1).

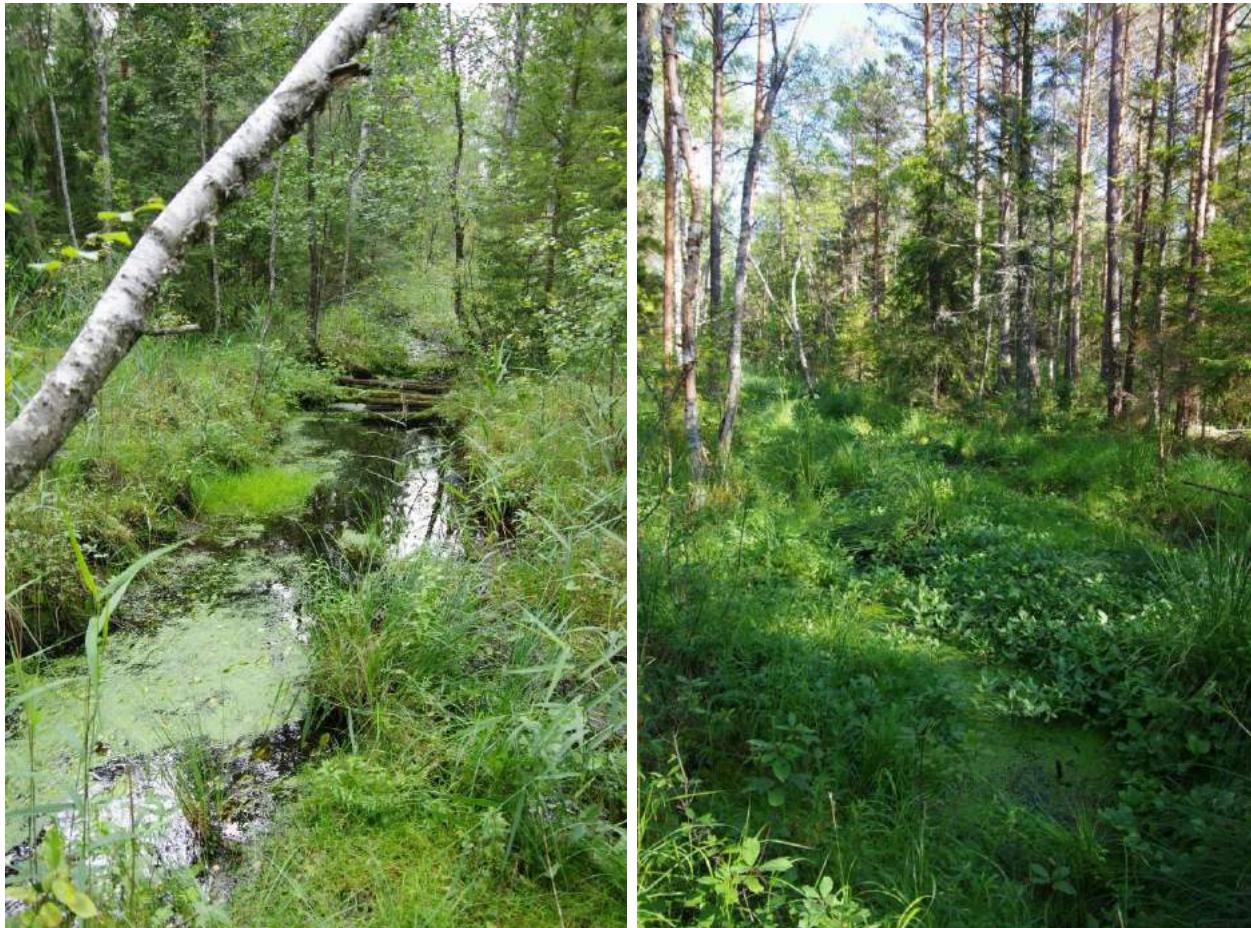
*Ditches in south-eastern part of the project site, surrounded by drained peatland forests (GEST Moderately moist forests and shrubberies) – previous open alkaline fens.*

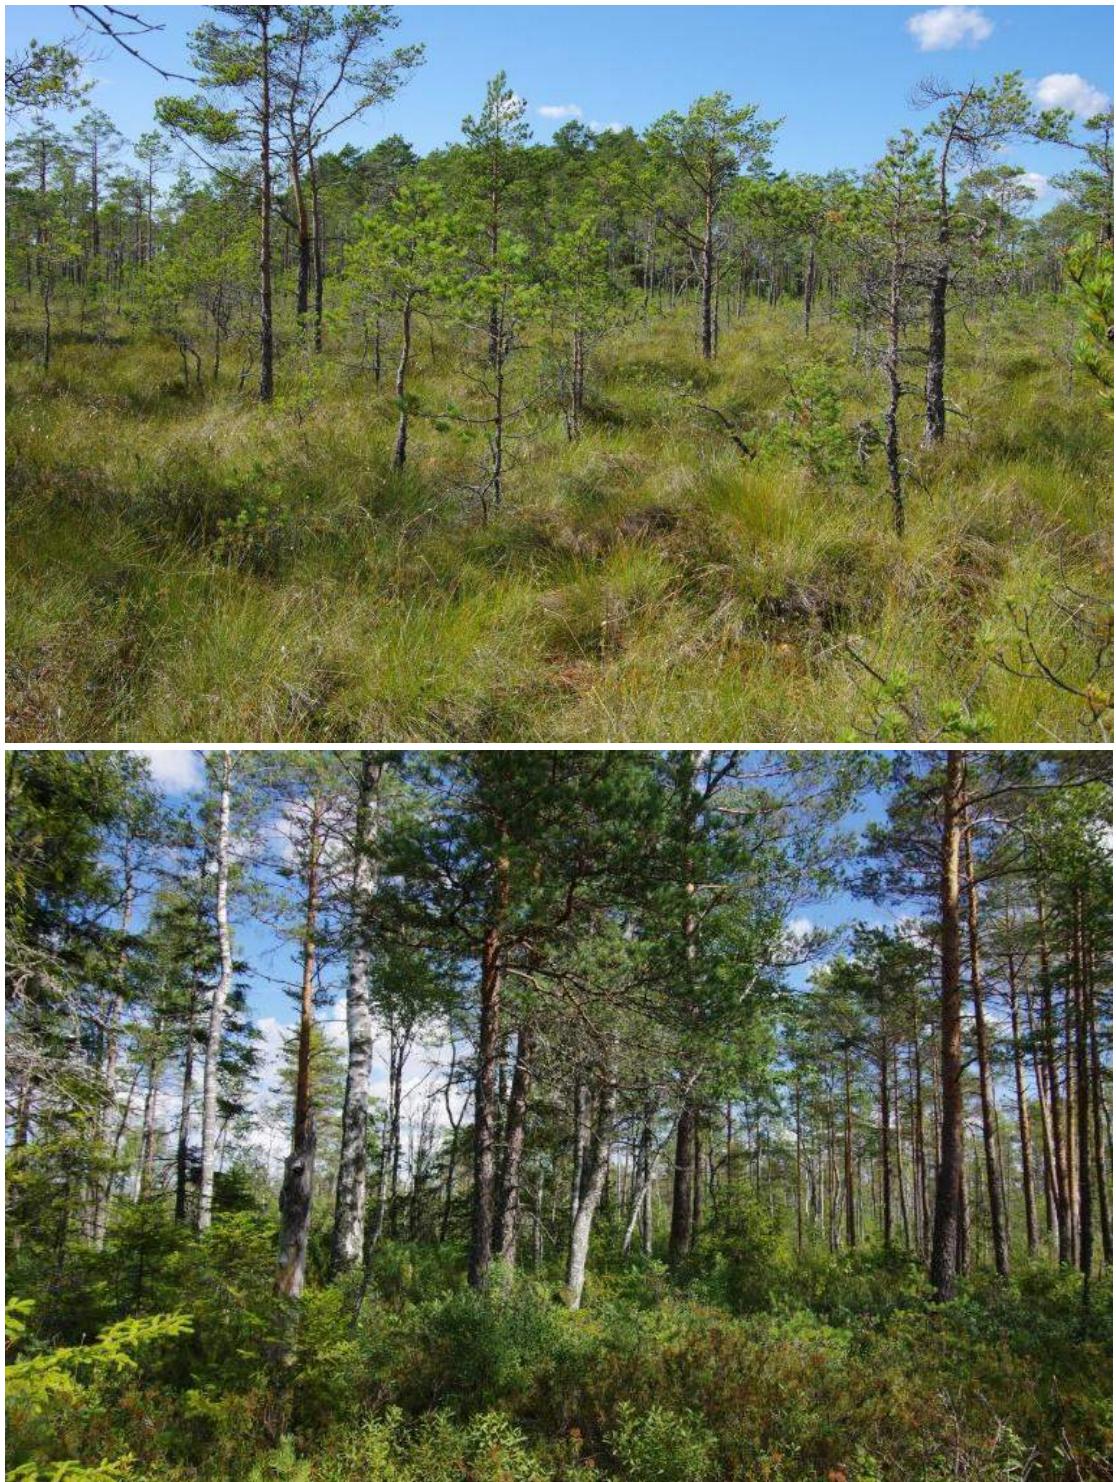
Transitional mire (GEST Wet peat moss lawn) and mire forest (GEST Very moist forests: Sphagnum – *P. sylvestris* community) – previous open alkaline fens.

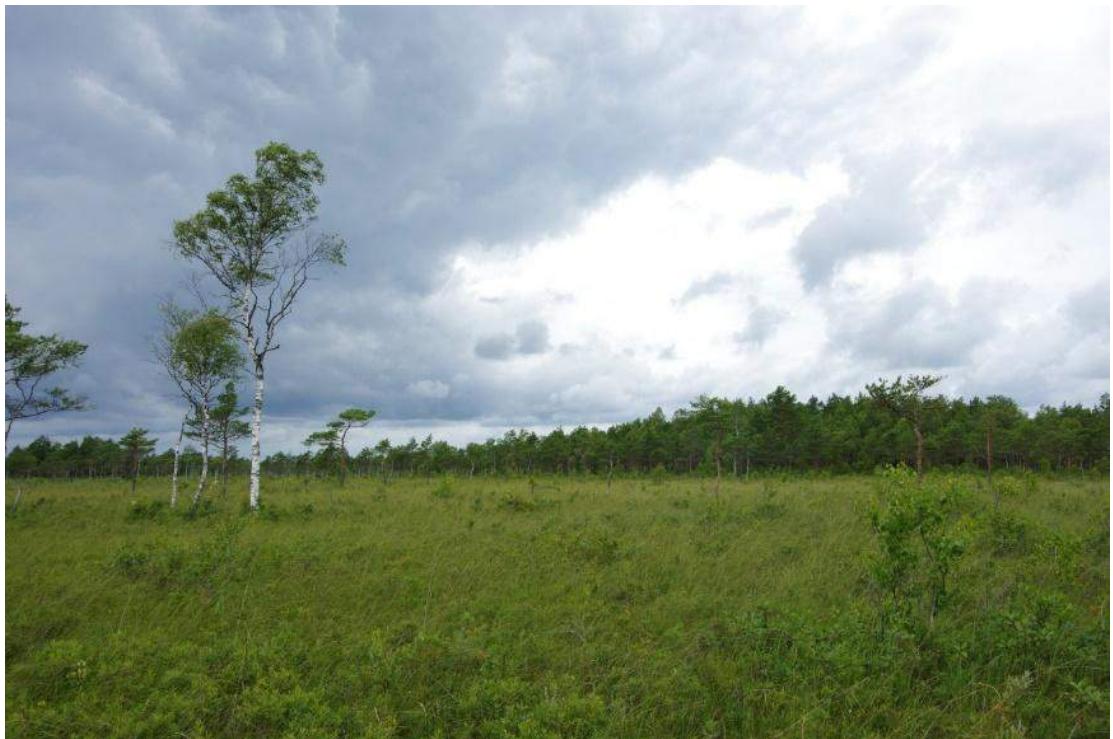
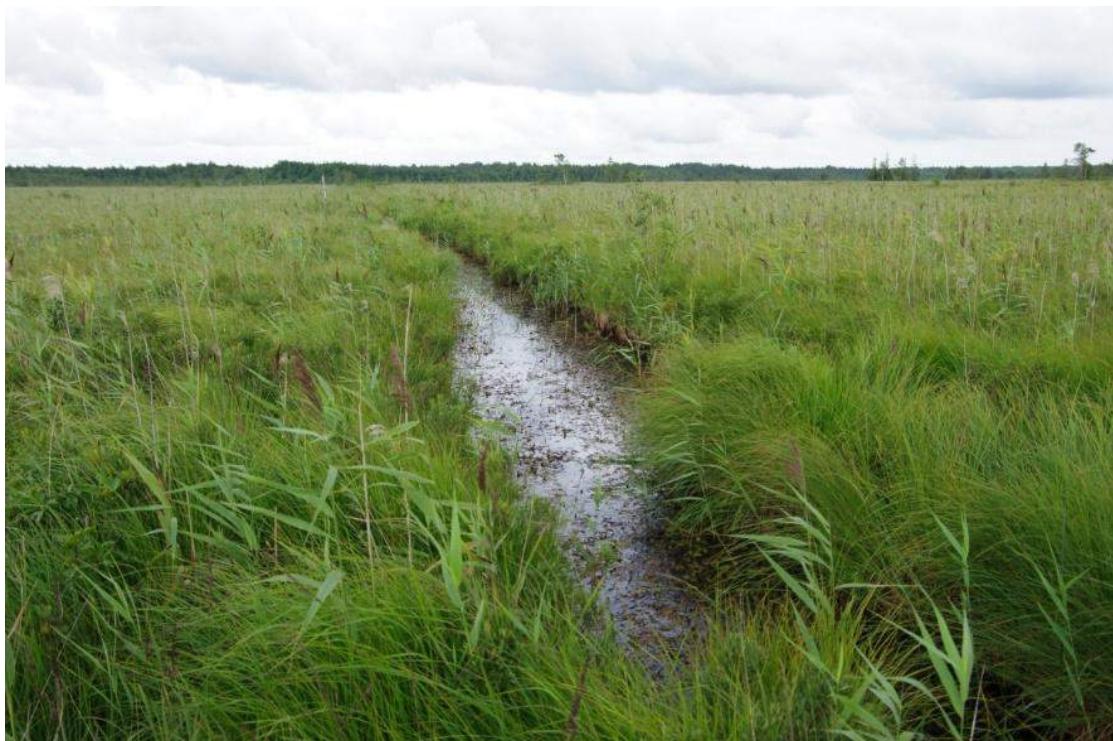
*Still preserved alkaline fens (GEST Very moist calcareous meadows) and crossing ditch Pennu stream in eastern part of the project site.*

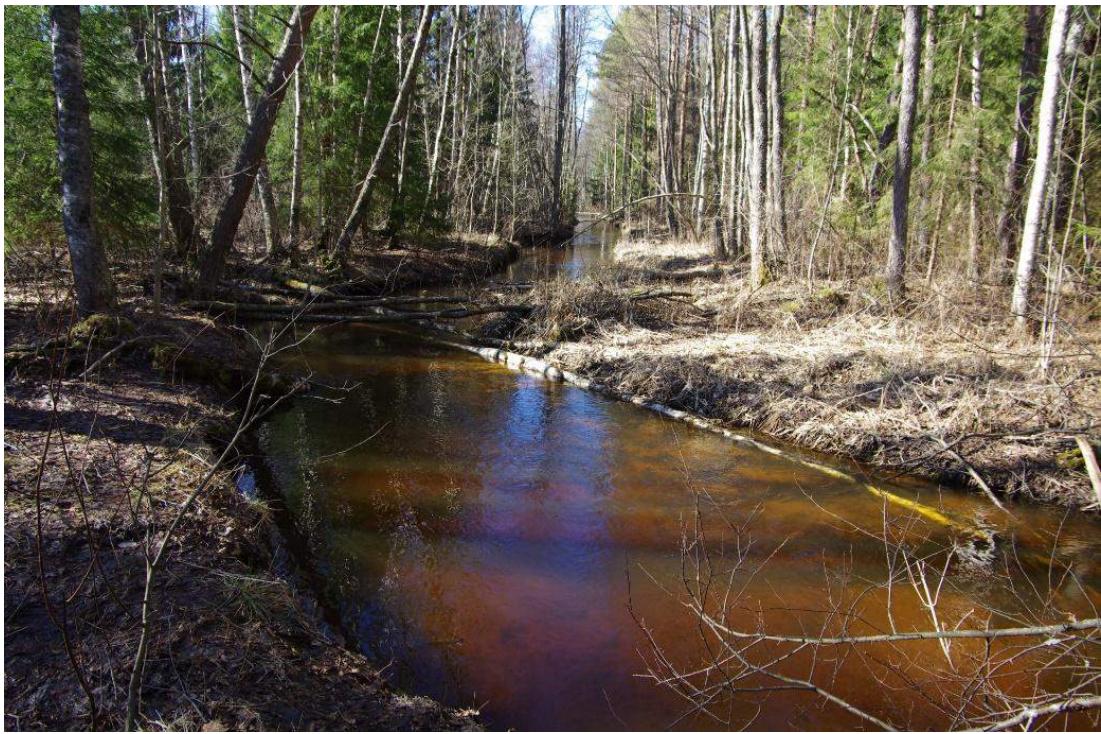
*Kaldamäe stream entering to the project site in eastern margin.*

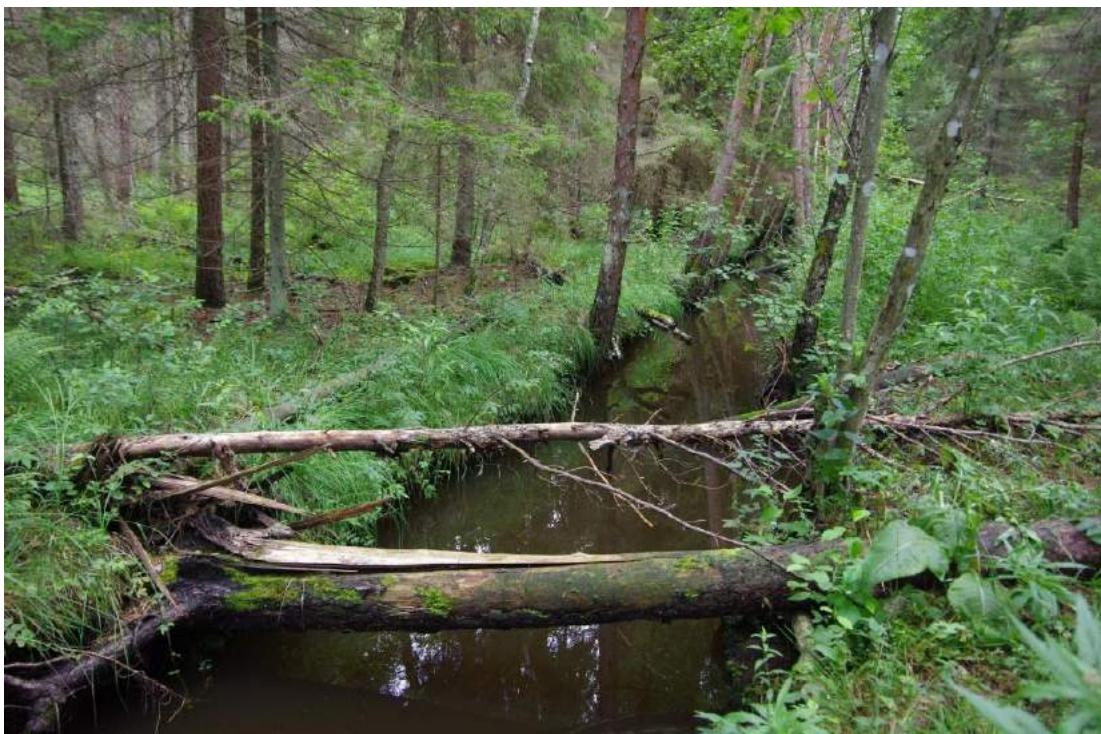
*Kaldamäe stream on the middle part of the project site (2.3 km downstream) surrounded by drained peatland forests.*

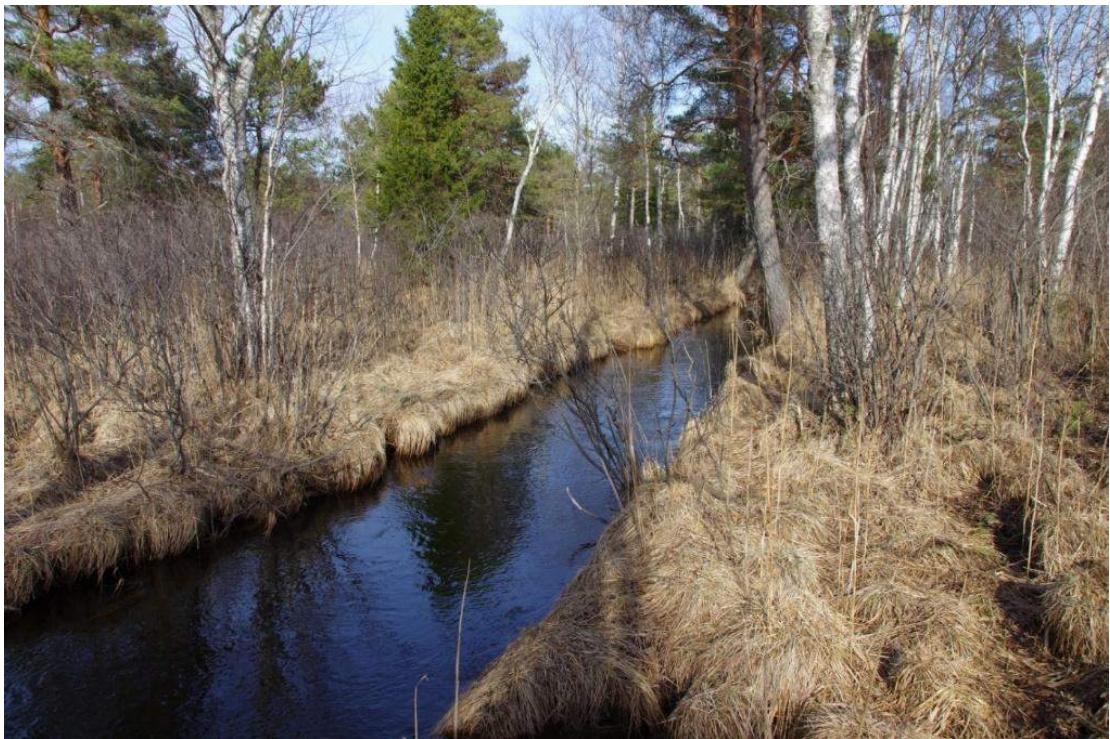
*Pennu stream in the middle of the project site.*

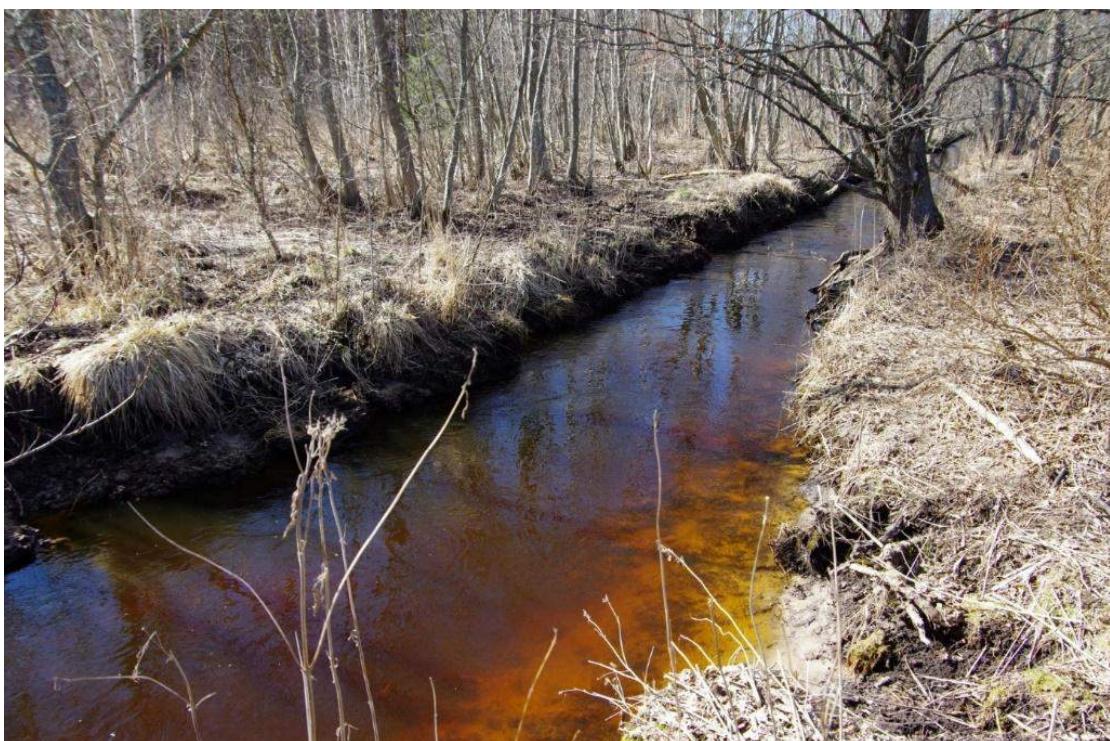
*Piirsalu River in the south-eastern part of the project site.*
