**LIFE project LIFE CCM DE/15/000138  
LIFE Peat Restore**

**«Reduction of CO<sub>2</sub> emissions by restoring degraded peatlands in Northern European Lowland»**

**State of the project sites and consequences for project  
implementation – results of field surveys.  
Documentation. A3**

**LITHUANIA**

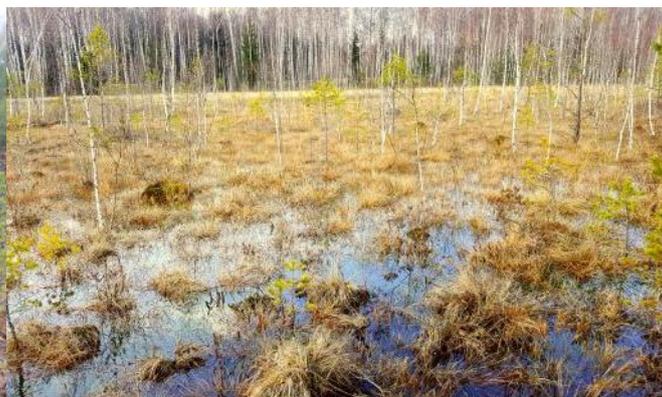
40 years of spontaneous revegetation created mosaic vegetation cover in abandoned parts of Sachara LT03 peat mining fields.

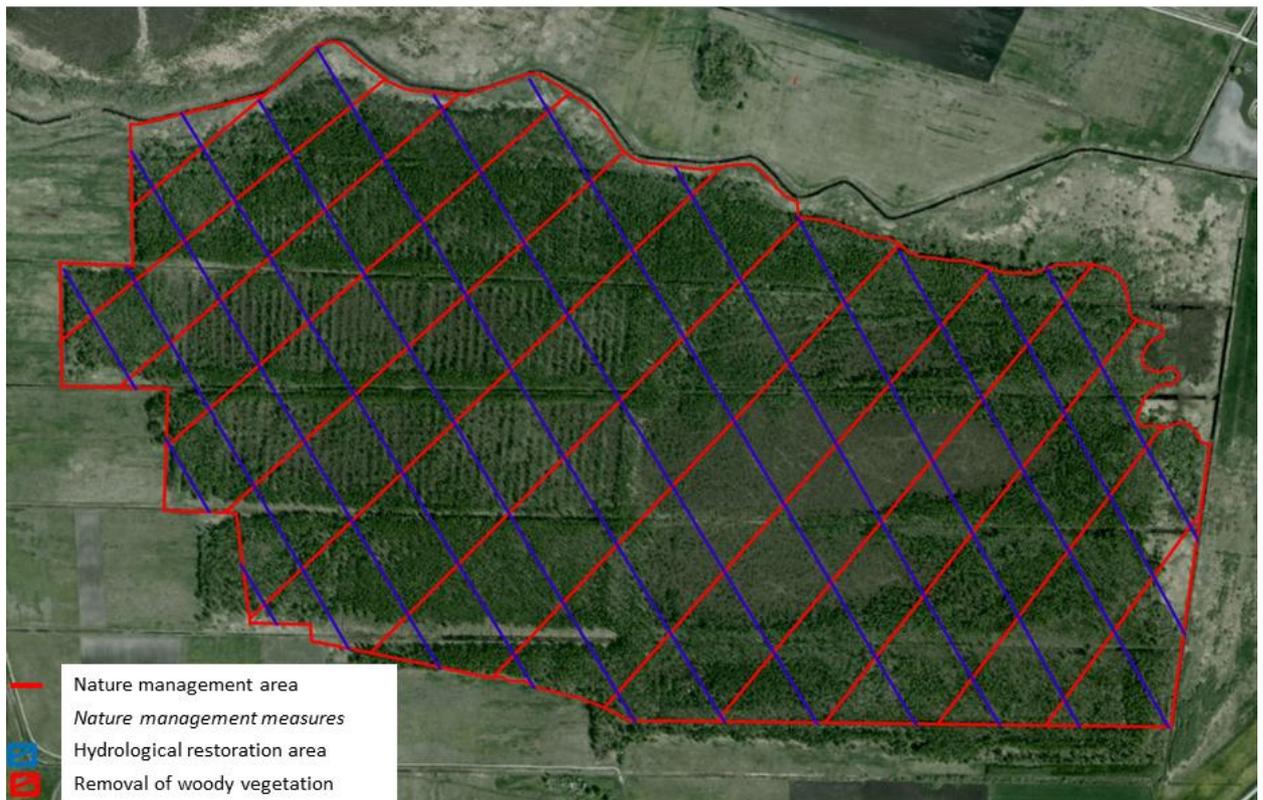
Annex 1. Nature management scheme in Amalva LT01 site

Draining of the southern part of Amalva was carried out already in the beginning of 20<sup>th</sup> century and continued during the soviet period. As a result, fen and transitional mire habitats were lost. The area has very uneven surface differing from one part to another by 1 meter or more. Transformation of hydrology of the area has started in the beginning of 20<sup>th</sup> century. The biggest impact was made in 1951 and later in 60s–80s, first the northern part was drained, later the reclamation was implemented in southern part (Peat Restore project area). Drainage network was established in fens suitable for agriculture and also in the part of raised bog. Currently only habitats of 7120 *Degraded raised bogs still capable of natural regeneration* can be found in the project site. Geological survey revealed that peat extraction in this peatbog is not suitable,

For the restoration of **Amalva peatland LT01** tree clearing and damming will be prepared in the whole site (215 ha). Nature management plan was approved before the project start in 2016 (<http://gamtotvarka.am.lt/plans/316.pdf>). Almost whole site is overgrown by forest. Approximately 215 ha of forest (birch, pine trees, shrubs) will be cut in order to increase the area of open peatland habitats and to reduce negative impact of tree evapotranspiration. Tree clearing will start before the implementation of the hydrological restoration actions. Forest management plan is in the process of approval, however 16 ha of young forest (dominated by birch trees) is already cleared, the rest of the territory will be cleared by the State Forestry Enterprise. Forest clearing will be prepared following the instructions provided in the Nature management plan, which foresee clear cuttings in the whole site and leaving some of the black alder and dwarf-forms of pine trees. In order to restore hydrological regime, 4 types of complex dams (total amount 37) will be installed. Valuable timber will be taken away from the bog. The branches of cut trees will be laid into the drainage ditches in order to restore damaged landscape of the bog and to create favourable conditions for establishment of *Sphagnum*. The site is surrounded by intensively farmed agricultural land; for this reason, the project aims to secure high water level inside the peatland. To ensure that neighbouring

farming lands will not be flooded 4 large complex dams with the pipes for the water outflow will be constructed on the edges of the site (Annex 1).

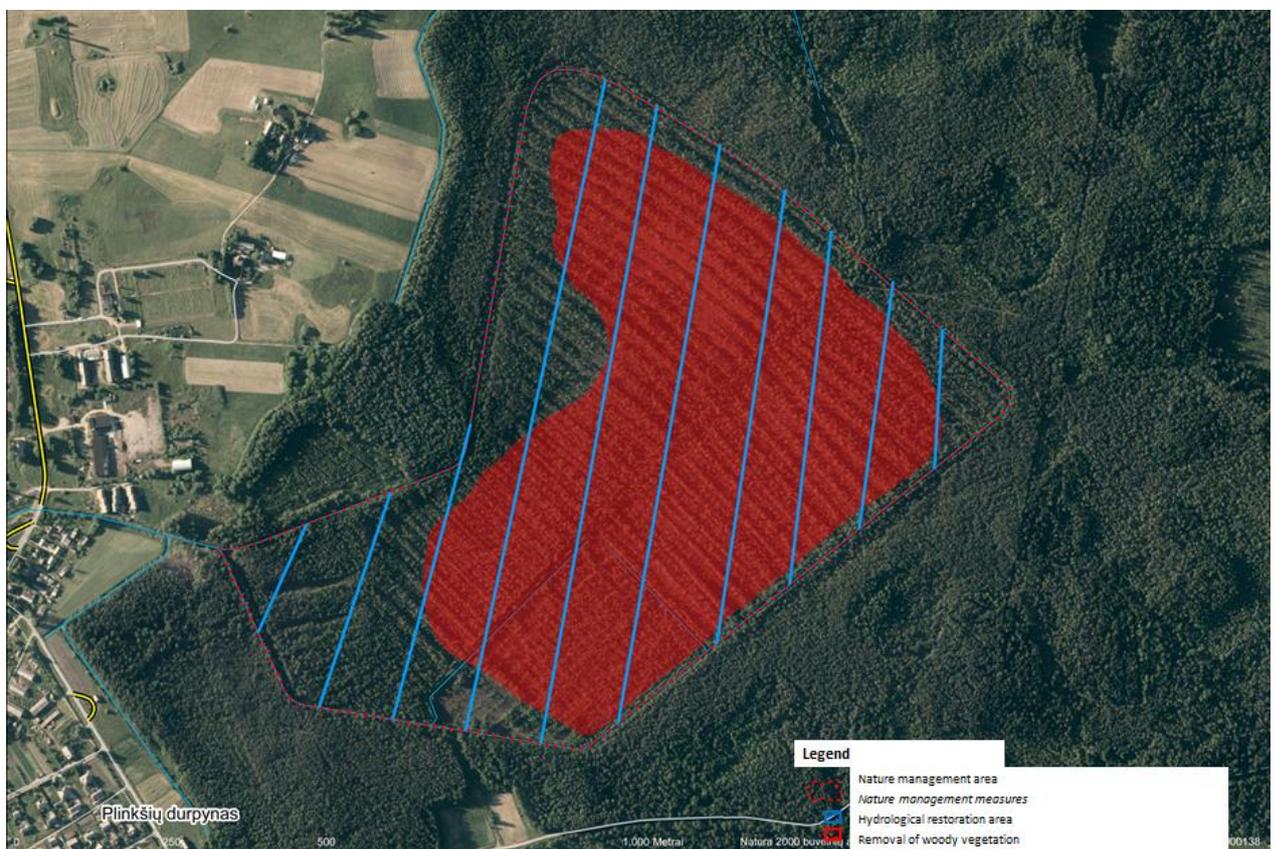
Annex 2. Nature management scheme in Plinkšiai LT02 site

Plinkšiai peatland is part of SPA Biosphere polygon “Plinkšiai forest and its’ surroundings” (LTMAZB001). However, permission for peat extraction for the Plinkšiai peatland was issued in 2002 before setting the Natura 2000, therefore, the site has 2 contradicting targets: nature conservation vs intensive usage, and this impedes any further activities in the site, for the time being. The site is represented by EU habitats, typical for heavily impacted peatlands: 7120 *Degraded raised bogs still capable of natural regeneration* and 7150 *Depressions on peat substrates of the Rhynchosporion*. The area is partially drained by ditches (total length is 22 km). Peat layer was removed in the eastern part of the site (8 ha) leaving up to 1–2 meters peat on the bottom.

Restoration of **Plinkšiai peatland LT02** is under discussion. The European Commission (EC) confirmed that due to the complex and uncertain legal situation – valid peat excavation permission within a Natura 2000 site – the site could be omitted from the list of project sites. However, the clarification of costs of forest removal is still in process. Any savings under forest management (Action C.2) could be reallocated to the Plinkšiai peatland. The Nature management plan was approved before the project start in 2014 (<http://gamtotvarka.am.lt/plans/278.pdf>). For the restoration of the site, hydrological restoration measures will be implemented in the whole area. To increase the area of open peatland habitats and to reduce negative impact of tree evapotranspiration approx. 40 ha of forest (birch, pine trees, shrubs) will be cut. In addition, this action will help to conserve the population of black grouse, which is currently vulnerable (Annex 2).

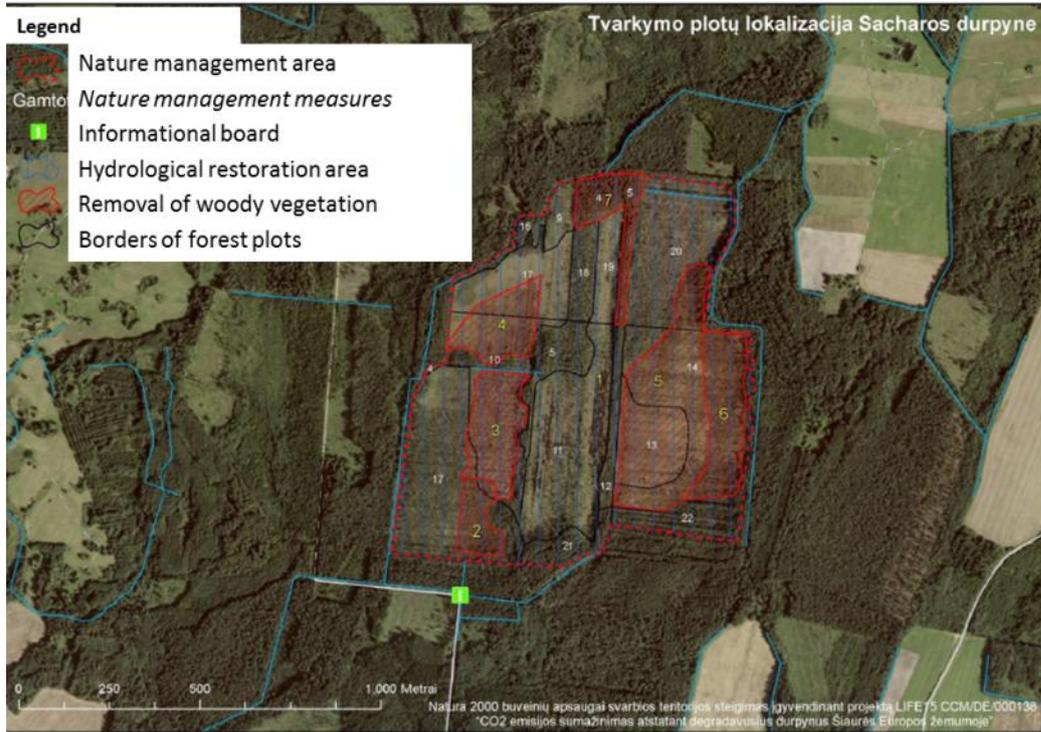
Annex 3. Nature management scheme in Sachara LT03 site

Peat mining started in 1941 and closed in 1981. Habitats of 7120 *Degraded raised bogs still capable of natural regeneration*, 7140 *Transitional and quaking bogs* and 91D0\* *Bog Woodlands* are characteristic to Sachara peatland. Ditches (total length is of 37 km) caused a strong drainage of the area. Low water level caused the intensified growth of trees and shrubs. As a result, the site is in the constant fire risk. Almost 40 years the territory is abandoned, part of the wetland is naturalized by spontaneous revegetation.

For the restoration of **Sachara peatland LT03** approx. 100 dams and 3 embankments will be installed. To increase the area of open peatland habitats and to reduce negative impact of tree evapotranspiration 30 ha of young forest (pine trees, birch, and shrubs) will be cut. *Sphagnum* diaspores will be spread on the bear peat. Nature management plan (<http://gamtotvarka.am.lt/plans/336.pdf>) and hydrotechnical plan were prepared and approved in the frames of LIFE Peat Restore project. Hydrological restoration measures will be implemented in the whole project area (82 ha). Dams will be cascaded every 10–30 cm of surface inclination in perspective places for habitat restoration. Valuable timber will be taken away from the bog. The branches of cut trees will be laid into the drainage ditches in order to restore damaged landscape of the bog and to create favorable conditions for establishment of *Sphagnum* (Annex 3).

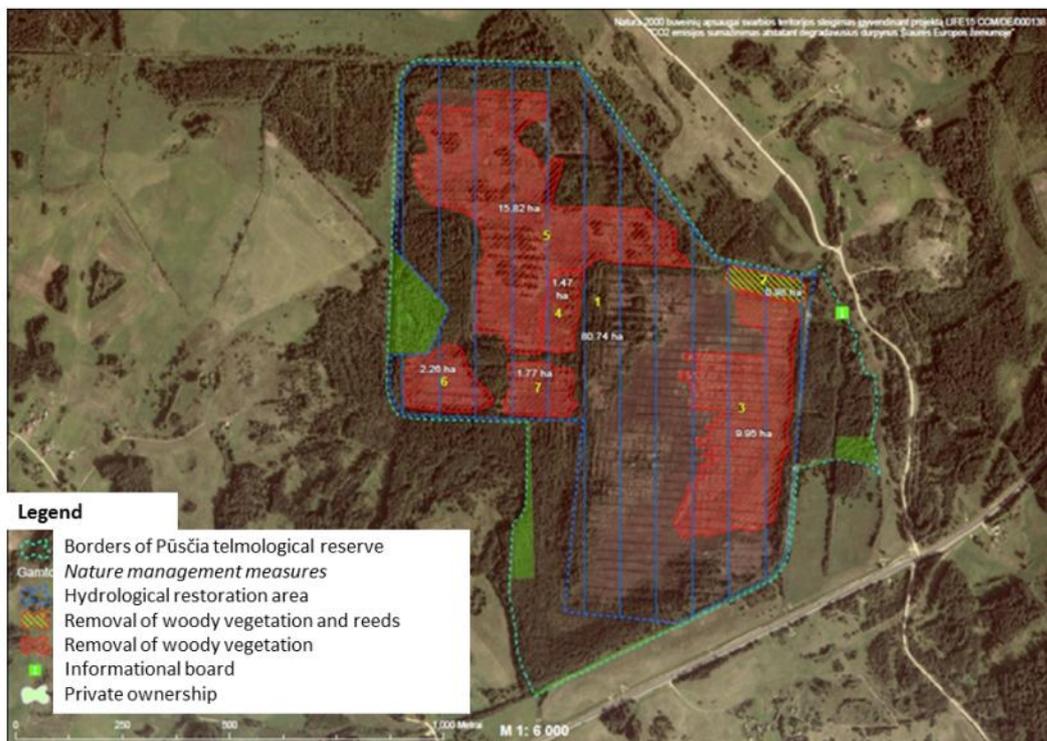
Annex 4. Nature management scheme in Pūsčia LT04 site

Pūsčia peatland (100.6 ha) has a status of Telmological Reserve, which was established in 2010 on abandoned for 20 years’ peat mining area. In 2006, Pūsčia peatland was appointed as pSCI (LTZAR0030). Currently, the site is abandoned for more than 30 years. Habitats of 7120 *Degraded raised bogs still capable of natural regeneration* (7120) dominate in the Pūsčia Telmological Reserve. In some areas 7150 *Depressions on peat substrates of the Rhynchosporion*, 91D0 *Bog woodlands* and 7140 *Transitional and quaking bogs* occur. A dense network of drainage ditches (total length approximately 35 km) leads to unfavorable hydrological conditions. Initial restoration attempts (in 2000) had a marginal effect so far. The central part of the peatland is overgrown by woody vegetation or covered by bare peat.

For the restoration of **Pūsčia peatland LT04** altogether 240 dams will be installed. In addition, to ensure stable water level approx. 10 protective embankments from peat and plastic will be constructed. To increase the area of open peatland habitats and to reduce negative impact of tree evapotranspiration altogether 30 ha of trees, mainly pine trees, birch and shrubs offshoots will be cut. *Sphagnum* diaspores will be spread in the bear peat habitats. A Nature management plan (<http://gamtotvarka.am.lt/plans/333.pdf>) and hydrotechnical plan were prepared and approved within the frames of the Peat Restore project. Hydrological restoration measures will be implemented in the whole project area (80,74 ha). Dams will be cascaded every 10–30 cm of surface inclination in perspective places for habitat restoration. Valuable timber will be taken away from the bog. The branches of cut trees will be laid into the drainage ditches in order to restore damaged landscape of the bog and to create favorable conditions for establishment of *Sphagnum* (Annex 4).

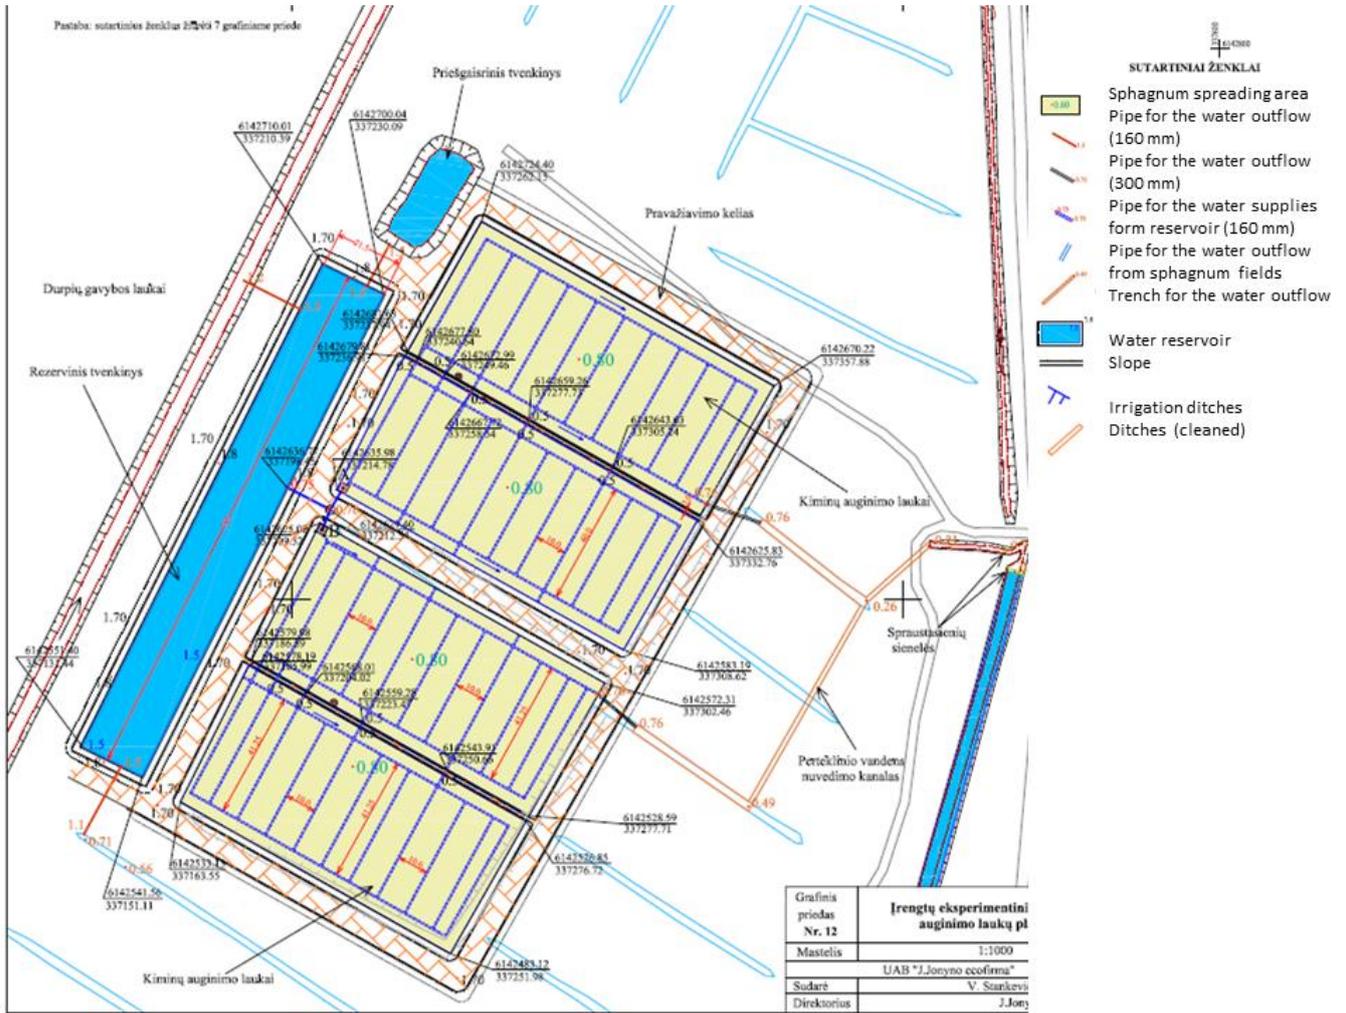
Annex 5. Technical design of *Sphagnum* establishment area in Aukštumala LT05 site

The project (10 ha) is located within the actively mined Aukštumala peatland. The project site is a part of Nemunas Delta Regional Park, which is protected by the Convention on Wetlands of International Importance (Ramsar territory) and is a NATURA 2000 site (SPA LTSLUB001 and SCI LTSIU0013). Peat mining is finished in the project site more than 10 years ago. About 0.3-1.0 m thick peat layer remained in this part of peat extraction field. Slight spontaneous revegetation is observed in some plots. The site is negatively influenced by the wide collective ditches, which surrounds the area. Moreover, active peat mining in the adjusting territories has a negative impact on hydrological conditions as well. Therefore, high water level fluctuations are evident in the site.

For the restoration of abandoned **Aukštumala cut-over peatland (Aukstumala LT05 site)**, *Sphagnum* spreading following the Canadian approach (Rochefort et al., 2003) will be performed. To ensure favorable hydrological conditions water will be supplied from the blocked ditches and shallow water pond. Experimental *Sphagnum* spreading field will be divided into smaller parts, which will be surrounded by the embankments (Annex 5).
