## LIFE Peat Restore

**LIFE project «Reduction of CO<sub>2</sub> emissions by restoring degraded peatlands in Northern European Lowland»**

# **State of the project site and consequences for project implementation**

# **ESTONIA**

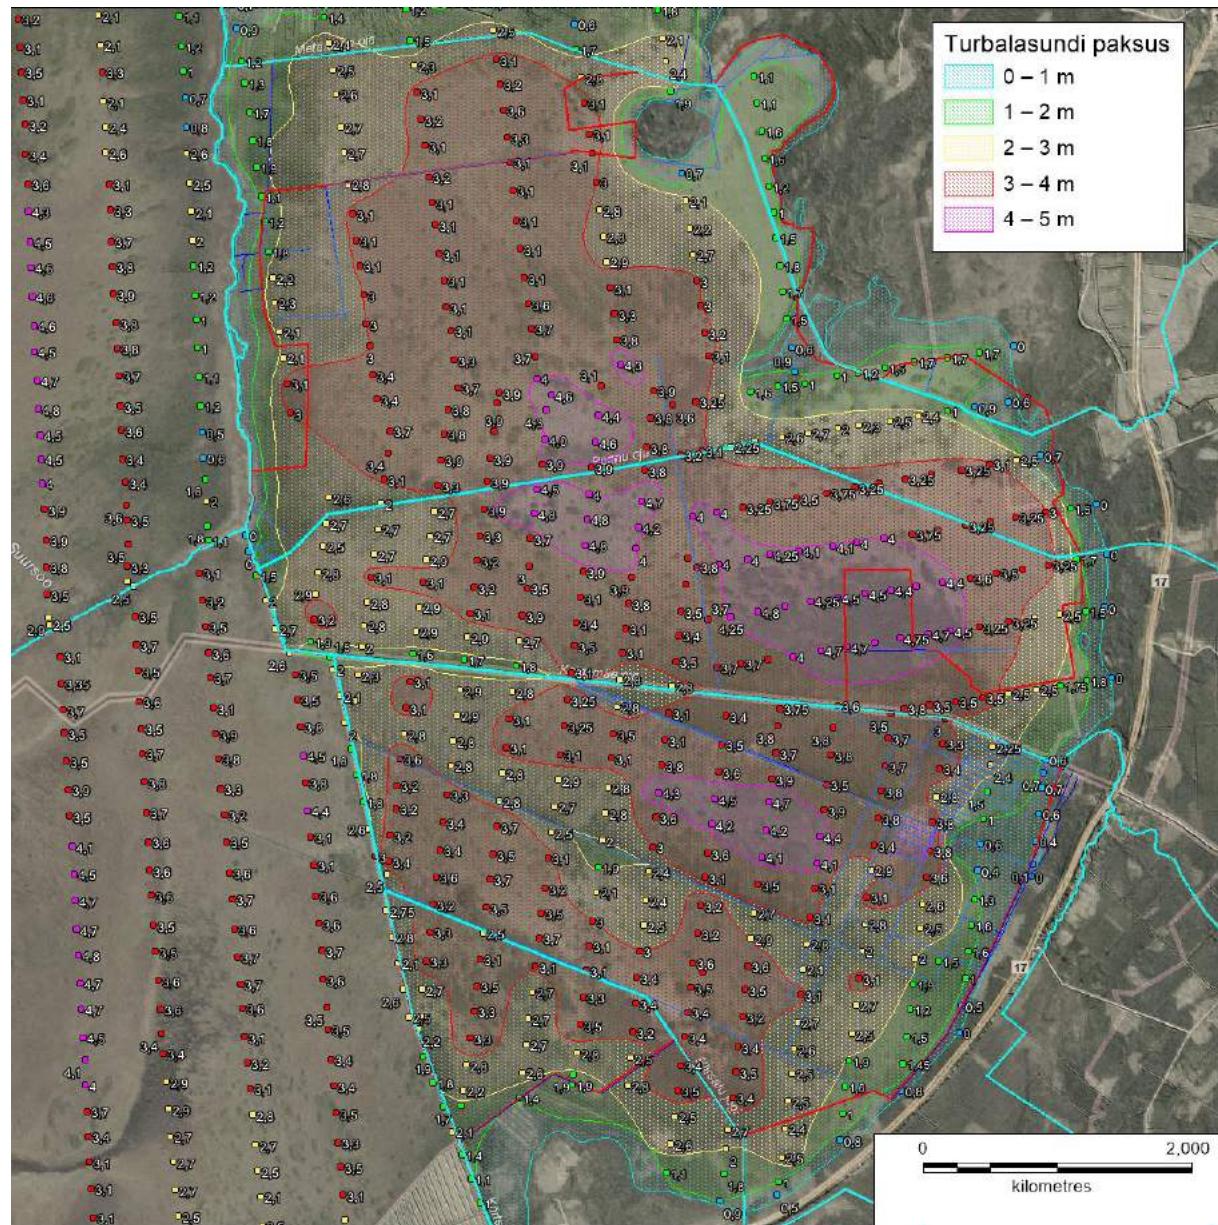
*Fig. 2. Map of peat depth on the Suursoo-Leidisoo project site (based on measurements of the Estonian Geological Survey, 1981).*

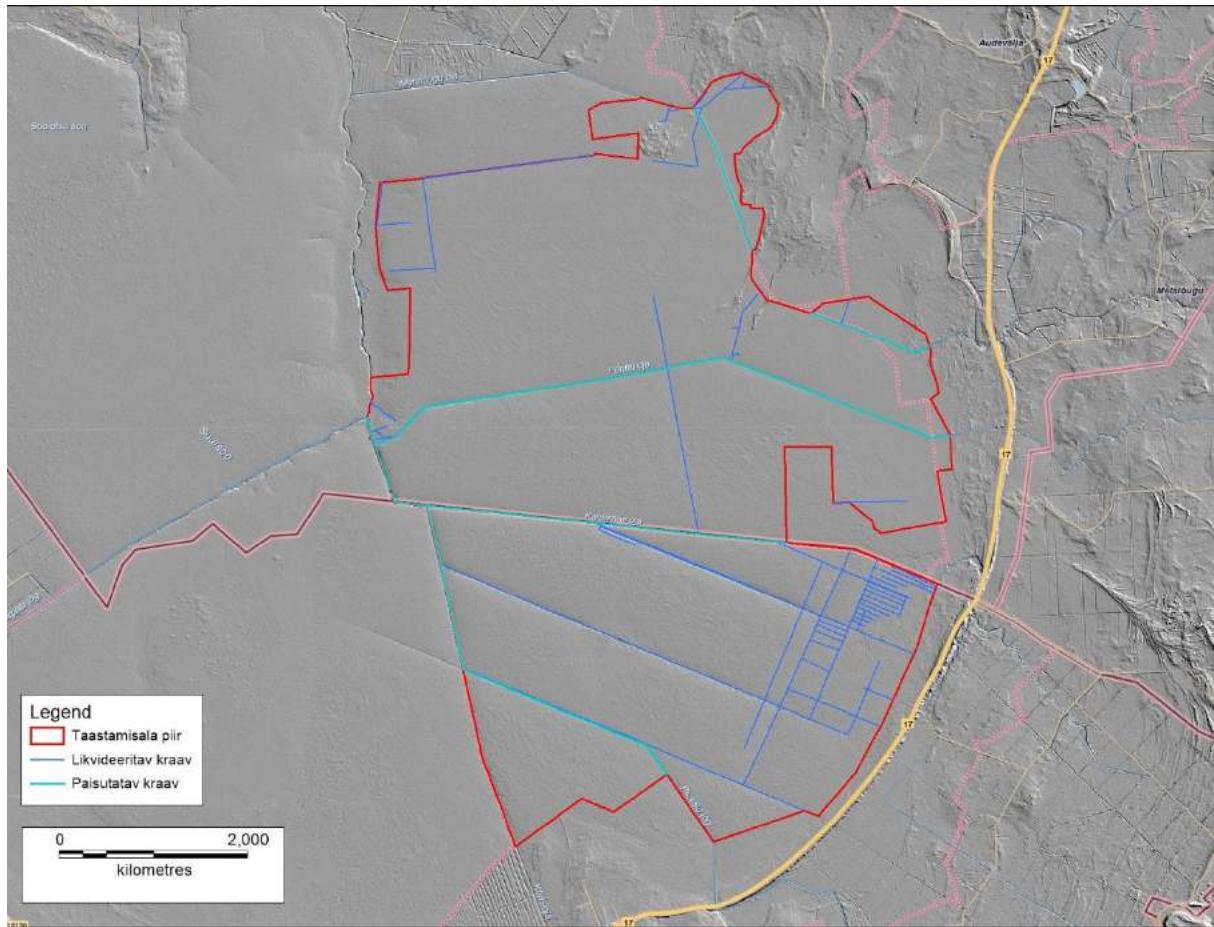
Fig. 4 Restoration site on the relief map of the Estonian Landboard with ditches that are planned to fill (blue lines) or dam (electric??? Lines). (Maa-ameti WMS-teenus)

Pennu, Kaldamäe and Metslõugu streams and the Piirsalu River will be dammed up to the level that does not influence the water table depth on areas out of the restoration site. Vihterpalu River and Kõrtsioja stream will not be influenced by restoration actions on the restoration site.

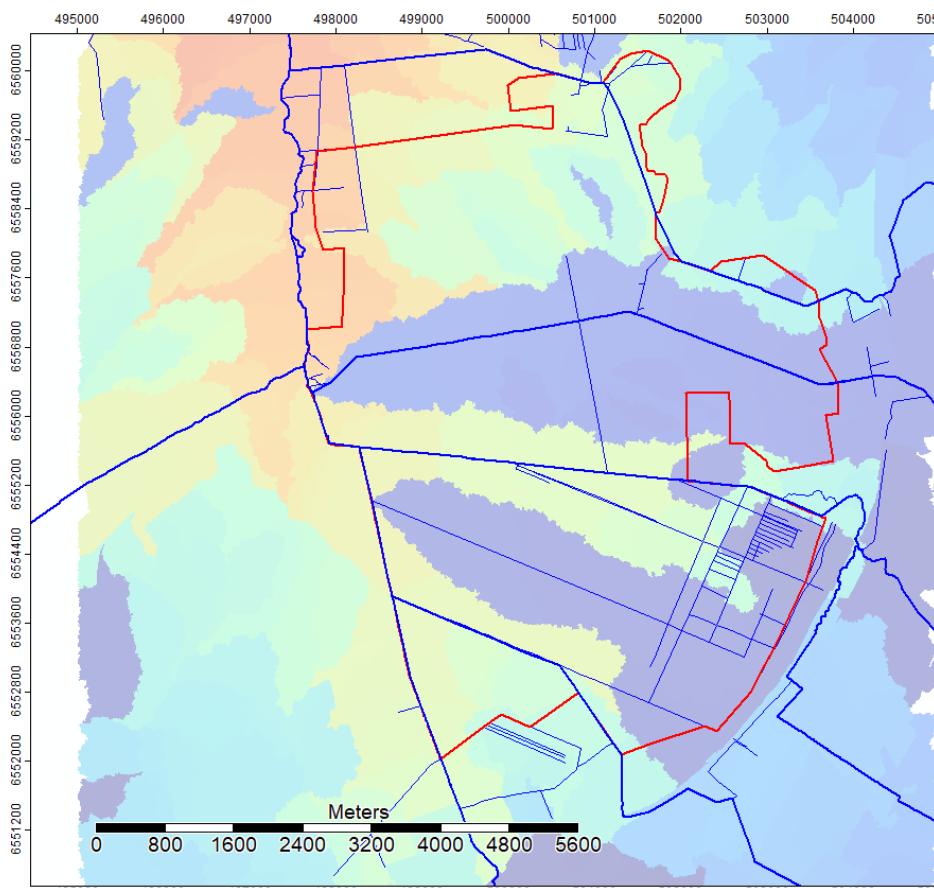
*Fig 5. Hydrological basins on Suursoo-Leidissoo restoration site. Constructed by SAGA GIS software using Estonian Land Board Elevation map.*

Overall conclusion of the monitoring and modelling data is that damming height should be as high as possible for the most ditches to maximize area of the positive impact of the water level raise. In several paces is need for the dams with wider “wings” to raise water outside the surface depression zone close the ditches. Exception is better preserved fen sites where it is enough to raise water up to the ditch banks and fen surface.

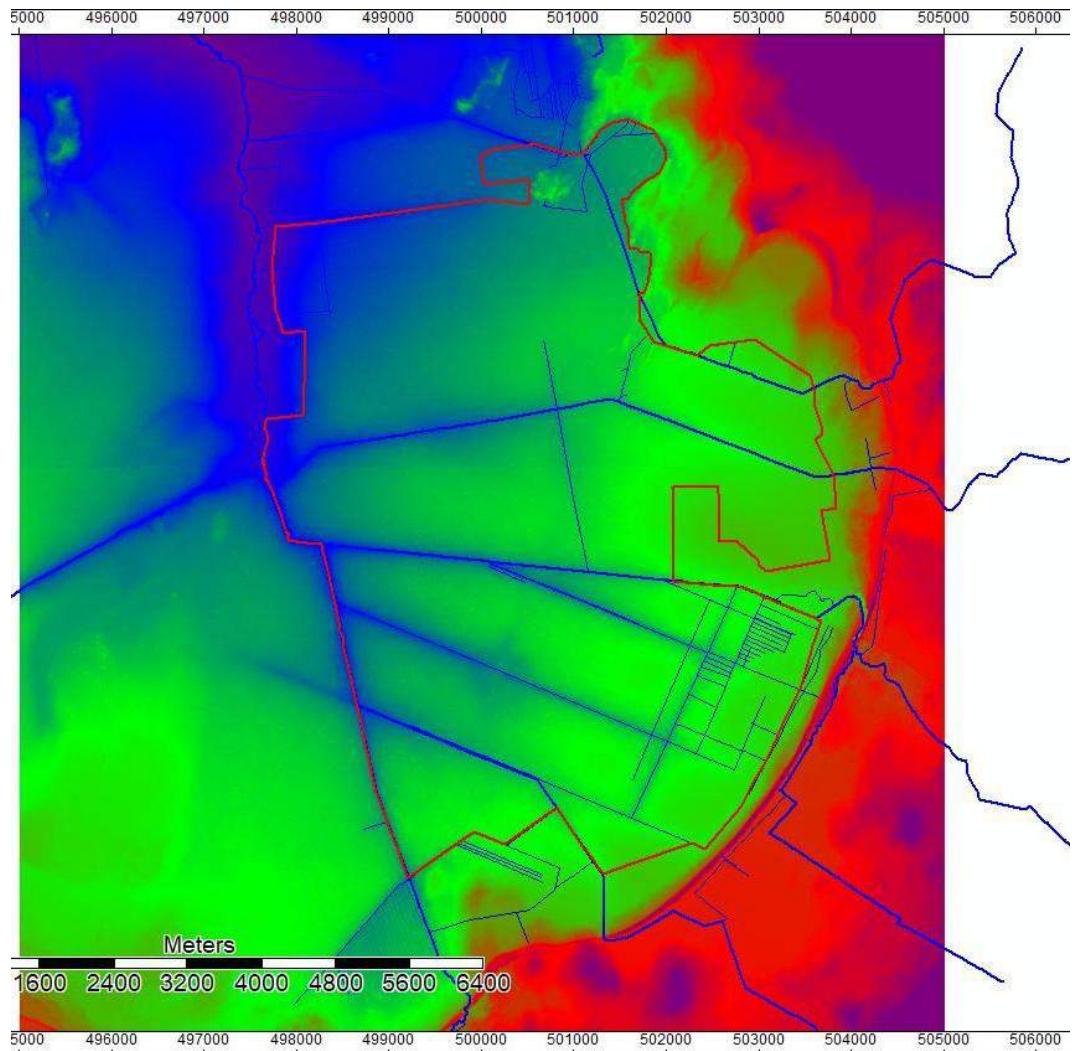
Results of the surface topography modelling (digital elevation model) indicate that ditches network has been changed importantly the surface topography as peat is compressed and mineralized and mire surface sunk importantly near the larger ditches. At the same time the *Sphagnum* growth and peat accumulation is going on watersheds away from the ditches. This changed local surface slopes, increased surface gradient and decreased flowline lengths. It means that runoff conditions are getting better for all parts of the restoration site. Historically the overall slope of the area was to the north-west towards the Vihterpalu River. At present, slope is towards the nearest larger ditch (Fig. 2) in most places. Maximum distance to the nearest ditch is ca 500 m but most of the areas located more close to the ditches. So the results indicate continuing negative impact of drainage and urgent need for restoration.

Fig. 6. Digital elevation model based on Lidar data – before damming of ditches.

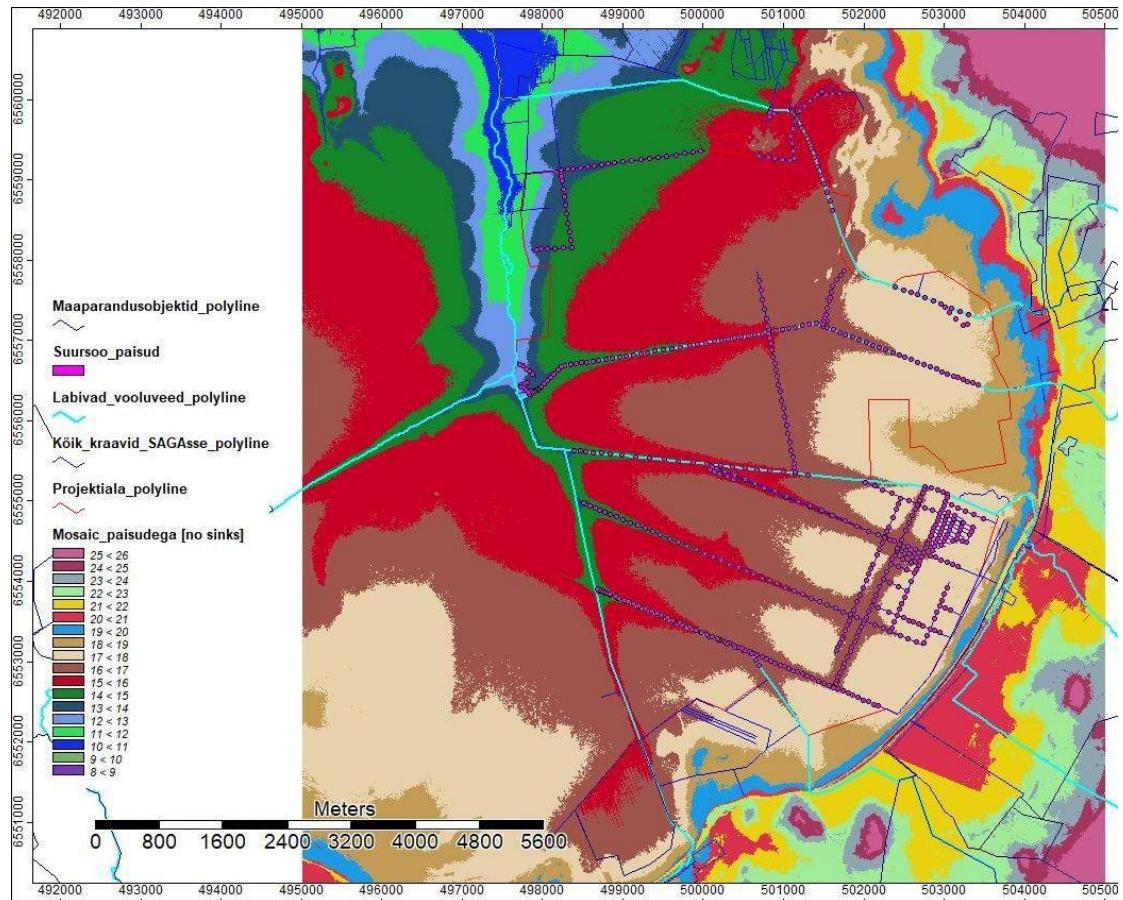
Fig. 7. Digital elevation model based on Lidar data – after damming of ditches. Dots on streams are expected sites for dams.

1. Relief model compiled based on Lidar-measurements of the Estonian Landboard (Fig. 6). The model describes hydrological situation and flow paths at present inside the project site and in the surroundings. Based on this, prognoses map of water table raise compiled for Metslõugu stream, Pennu stream, and Kaldamäe stream, Piirsalu River inside and on the surroundings of the project site (Fig. 7).
